State College Area School District
High School North Building
EXISTING CONDITIONS ASSESSMENT

Prepared by CenterPoint Engineering
08 February 2013

FACILITY ASSESSMENT SUMMARY

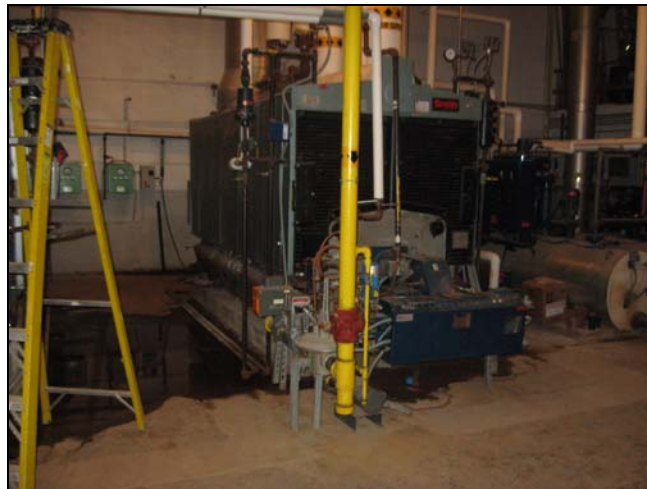
- The majority of the building is heating only.
- Heat is distributed throughout the building with steam. The steam is generated by two HB Smith 450 Mills cast iron sectional boilers. The boilers are gas-fired. It is believed they are approximately 10 years old and were reported to have no major issues. However, maintenance staff also reported having to replace sections as they go bad.

One of Two Steam Generating Cast Iron Sectional Boilers

- Central heating plant equipment still has part of its average service life remaining. The system should be converted to hot water to minimize energy costs and ease of maintenance compared to steam. An analysis will be completed to compare conversion of the existing boilers to hot water versus new boilers.

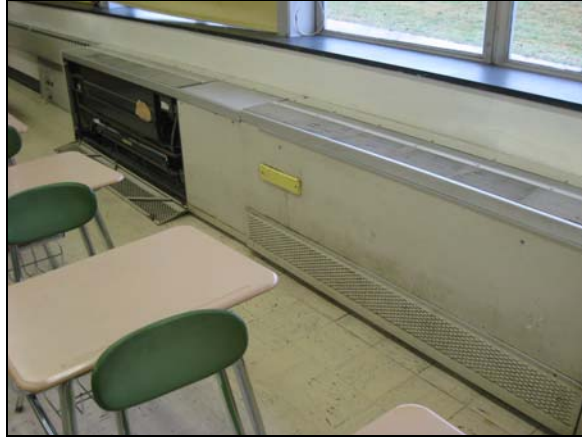
- Classrooms in the building are heated by unit ventilators. Other large spaces are heated by indoor air handling units or rooftop air handling units. Smaller spaces are heated by terminal equipment, such as unit heaters and convectors. The units serving the older areas of the building are in poor condition. Maintenance staff indicated many issues with the system including leaks and breakdowns.

Typical Classroom Unit Ventilator

- Parts for existing equipment will become more difficult to purchase making maintenance more difficult.
 - With the exception of the central plant equipment, the system should be replaced in its entirety with a more efficient system that provides adequate outdoor ventilation air.

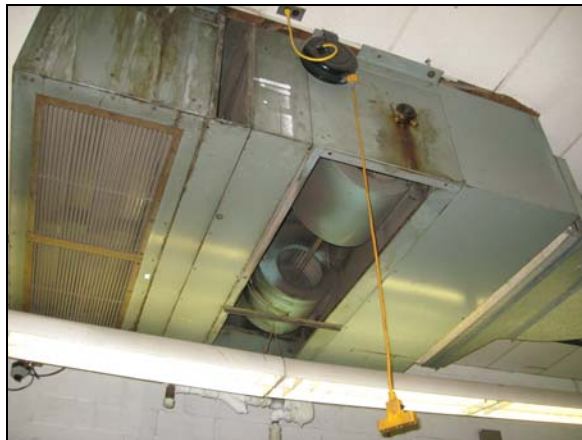
Indoor Air Handling Unit Horizontal Configuration Suspended by Structure Above

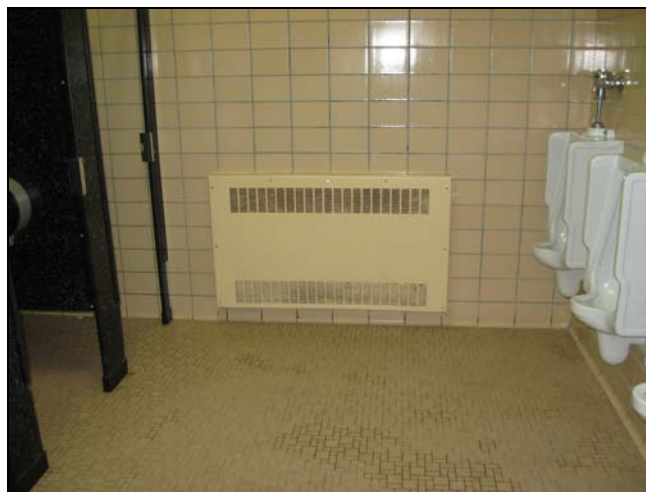
Heating Convectors in Typical Toilet Room

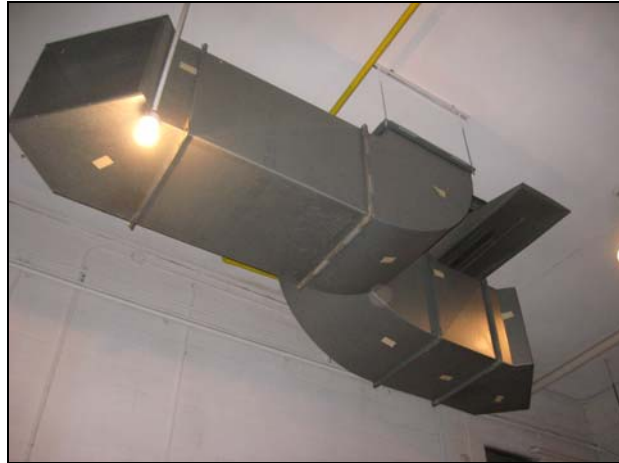
- Outdoor air is introduced into the building through the HVAC system. Each piece of equipment brings in outdoor air for the specific area it serves. Due to the age of the building and HVAC equipment, it is anticipated that the majority of the systems do not meet current Code requirements for outdoor air quantities.
- There is no smoke evacuation system for the stage. This is a requirement of the current Code.
- Combustion air is introduced into the boiler room through a makeup air unit. Age of the unit was unknown.

Combustion Air Ductwork at Boiler Room Ceiling

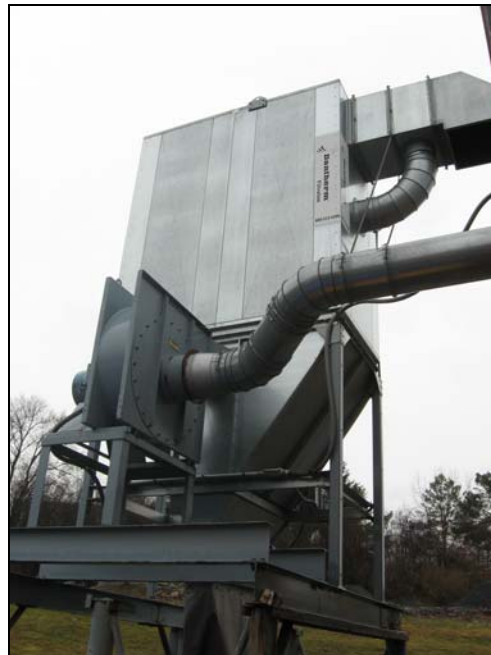
- The unit ventilators appeared to relieve air into the corridors. This is a violation of the current Code.
- The woodshop is served by a Dantherm dust collection system. The system is approximately 5 years old and appeared to be in good condition.

Dust Collection Unit for Woodshop

- Corridors are served by convector and fin-tube units that do not introduce outdoor air into these spaces, which is a violation of the Current Code.
- Recommendations:
 - New HVAC systems noted above should be designed to introduce Code required outside air into the building.
 - The woodshop dust collection system should remain.
 - A smoke evacuation system should be designed and installed for the stage.

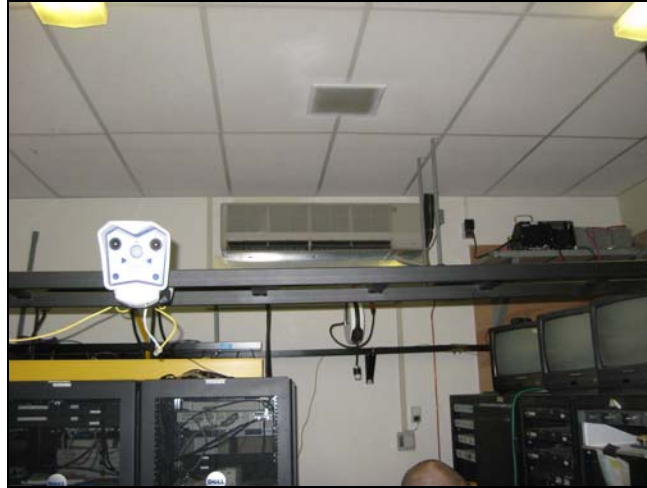
Indoor Section of Ductless Split System in IT Room

- The two band rooms are served by packaged rooftop units which were replaced approximately two to three years ago.
- Several areas were noted as being served by window air conditioning units.
- Recommendation:
 - With the exception of the band room, the air conditioning equipment is at or near the end of its average service life and should be replaced.
 - Consideration should be given to providing air conditioning for the entire building.
 - Window units should be replaced with more efficient systems if these areas will continue to be air conditioned.

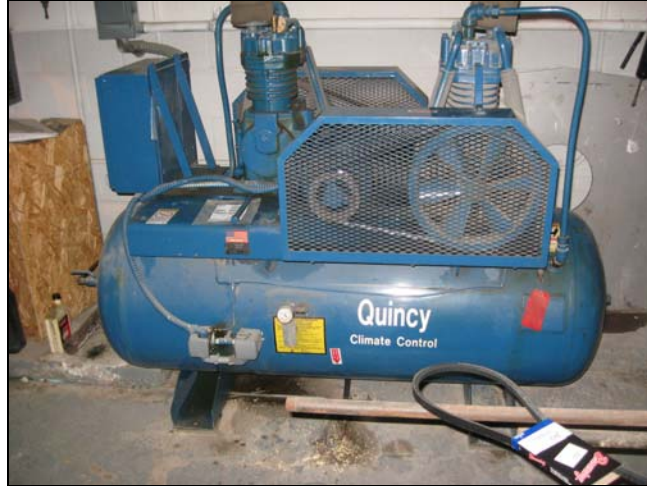
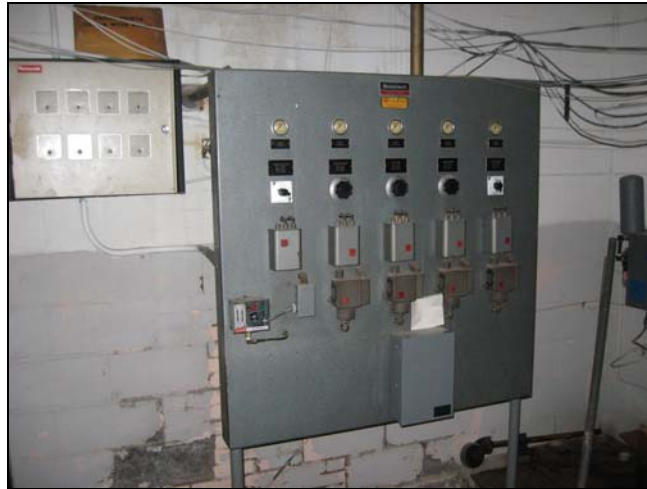
Air Compressor for Operation of Pneumatic Control System

Pneumatic Control Station

- The systems appeared to be in poor condition due to age. Systems of this age begin to show increasing amounts of leaks which make control difficult.
- Recommendation:
 - A direct digital control (DDC) automatic temperature control system should be installed when a new system is installed. This will allow for the most efficient control of the new equipment.

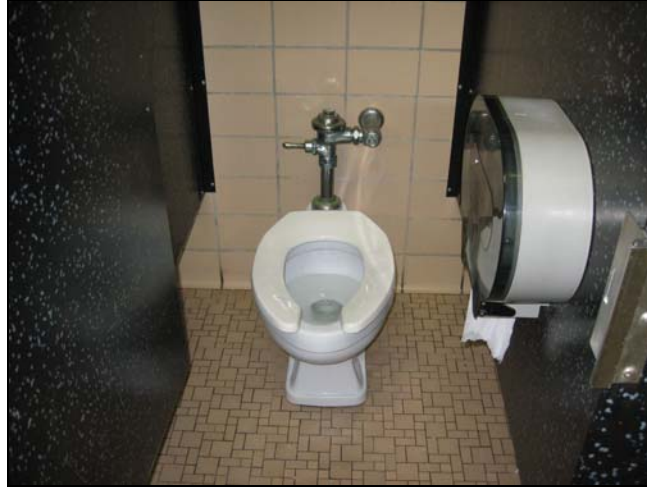
- Water closets are floor-mounted flush valve type.

Water Closet

- Plumbing fixtures are original to their time of construction.
- It is assumed from the time of construction, that the fixtures do not meet the current water flow requirements of the International Energy Conservation Code.
- Recommendation:
 - Plumbing fixtures should be replaced.

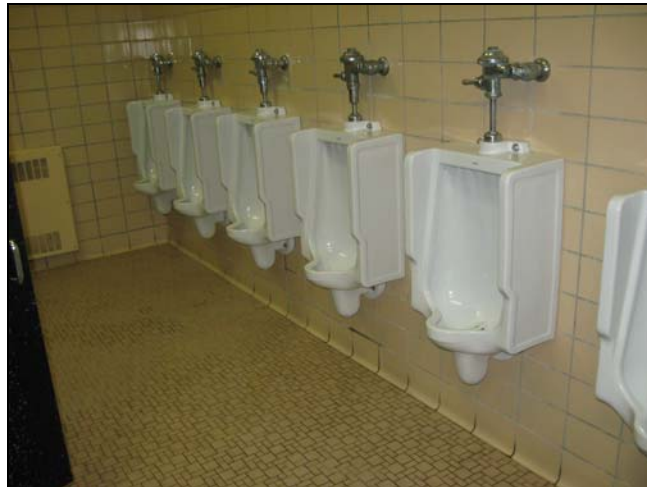
- Urinals are wall-mounted flush valve type.

Urinal

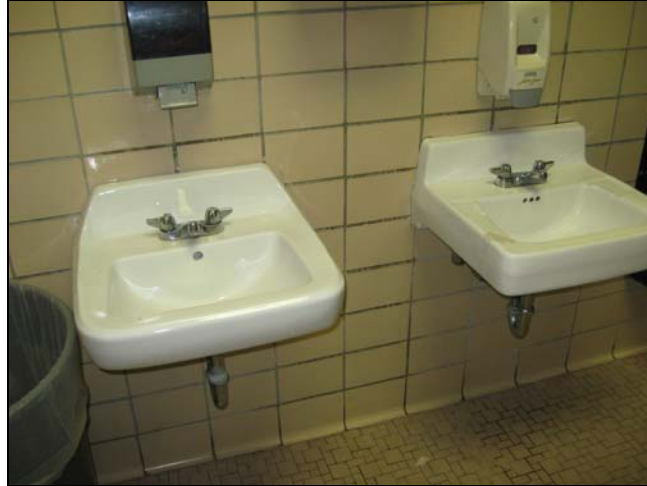
- Lavatories are wall-mounted type with a variety of faucet/handle styles.

Lavatories

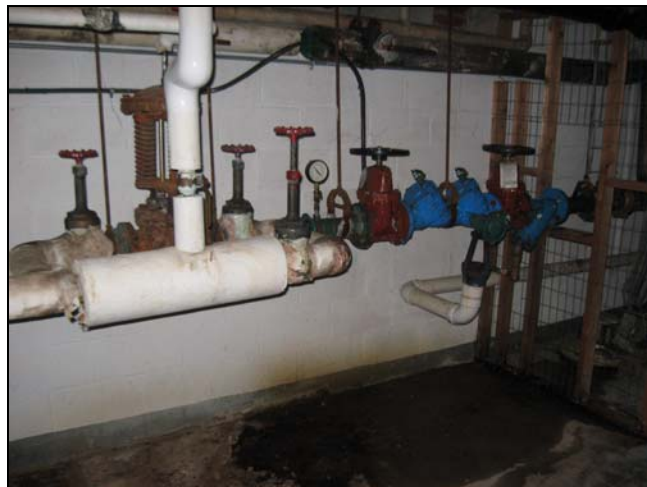
- Water service is provided by the State College Borough Water Authority.
- Water pressure was read at the backflow preventer between 75 and 80 psi.
- The water service enters the building in its own room. There is a Zurn Wilkins 3" backflow preventer to protect the service as well as a pressure reducing valve.

Water Service Entrance

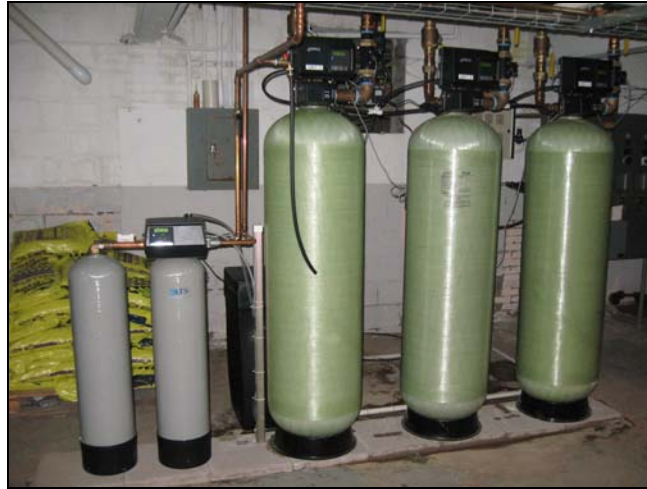
- A Marlo water softener is located in the boiler room. Time of installation is unknown. It appeared to be in good condition.

Water Softening System

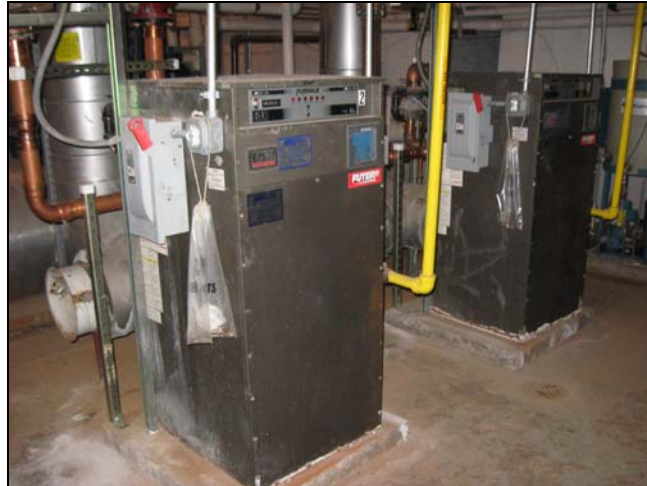
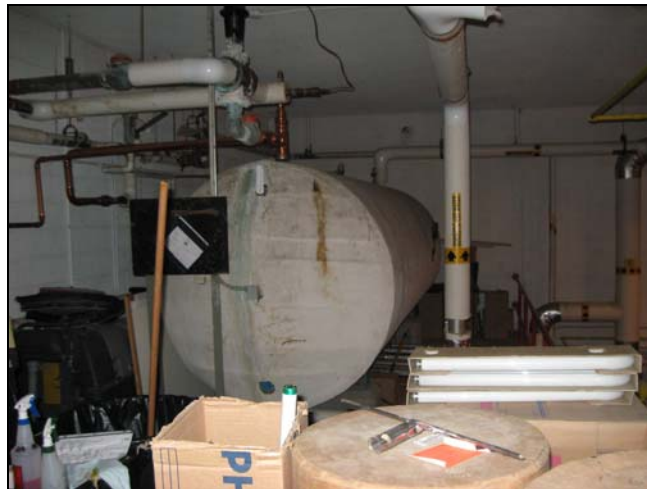
Boilers Used for Domestic Hot Water Generation

Domestic Hot Water Storage Tank

- The boilers are approximately 10 years old and were re-tubed last year. It seemed unusual that the boilers would need to be re-tubed at nine years. Typically, a boiler will last approximately seven years after being re-tubed.
- Recommendation:
 - The domestic hot water generating systems should be replaced. A more efficient system type should be reviewed including strategic placement of domestic hot water generating systems if possible.

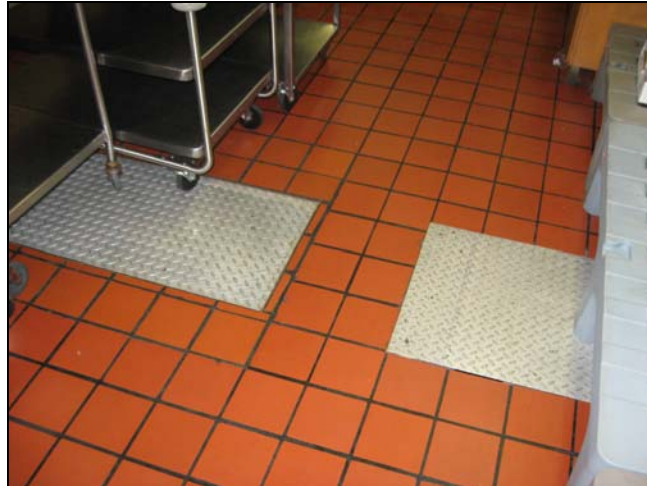
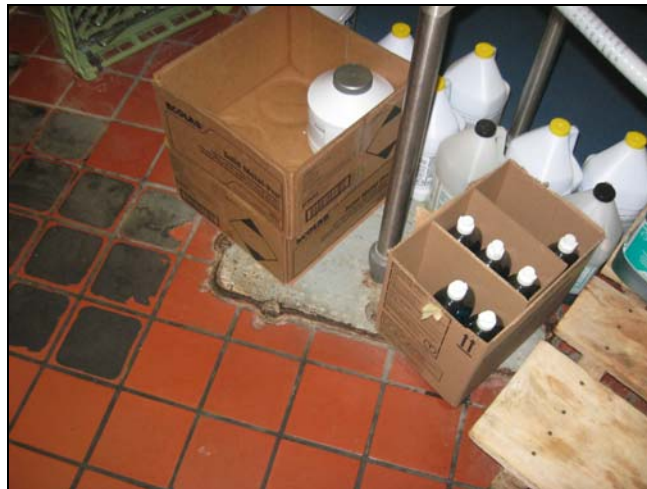
Grease Interceptors in Kitchen Floor

Grease Interceptor in Kitchen Floor

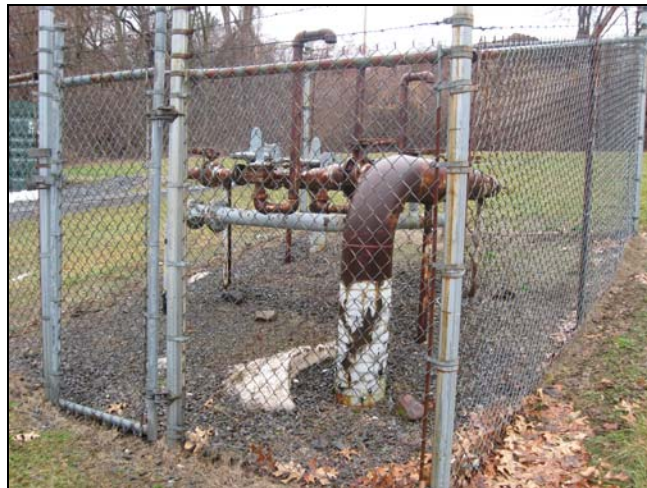
Main Natural Gas Service Entrance

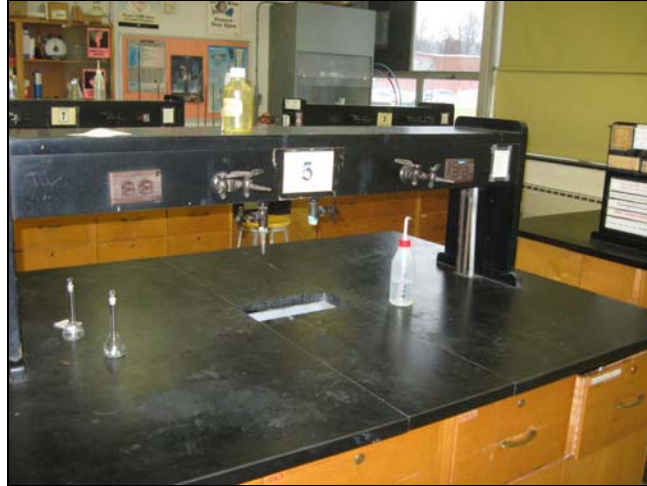
Science Lab Work Tables with Natural Gas Turrets

- Natural gas is distributed through welded black steel piping.
- No issues were reported with this system.
- Recommendation:
 - The system is in good condition. However, modifications to the system will be required based on changes to the HVAC, plumbing, and emergency generator systems.

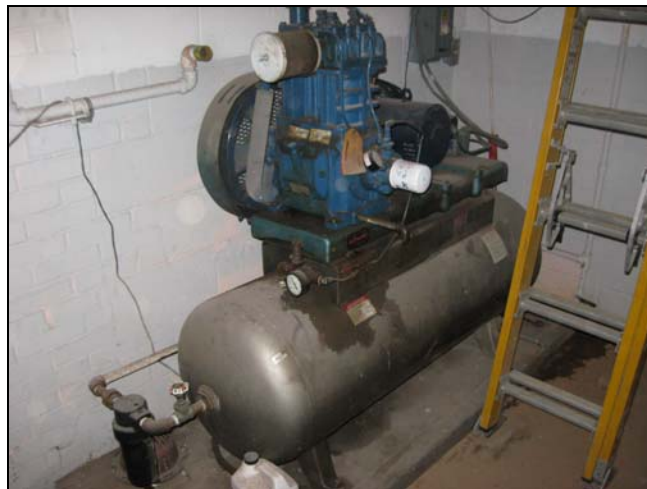
- There are two air compressors in the building. One serves the shop area. The other serves the temperature control system. The units are not believed to be original, but the time of installation is unknown. They are old in appearance and in fair condition.

Air Compressor for Shop Area

- Recommendation:
 - Replace the air compressor serving the shops. The temperature control compressor should be removed per the recommendation to install a new DDC type BAS.

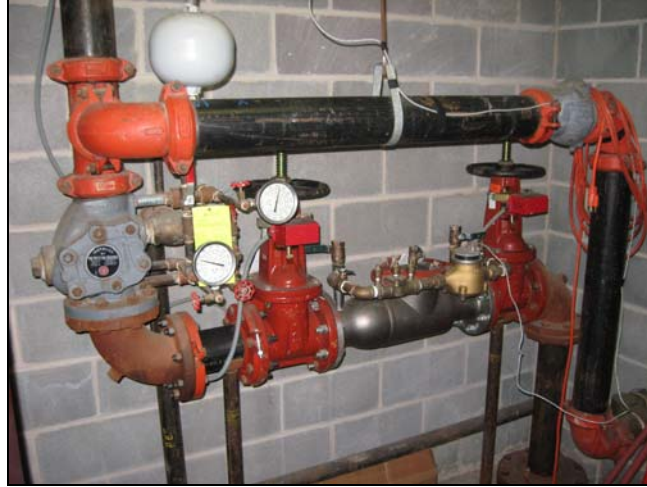
- The athletic areas in the north end of the building is protected by an automatic sprinkler system. There is one riser serving the building.
- The pressures listed on the testing tag were 72 psi static pressure and 65 psi residual pressure. No flow data was logged. No design data was listed on the valve.

Sprinkler Water Service Entrance

- The building does not have a fire pump.
- Recommendation:
 - Extend the system to cover the entire building. This may require a new water service. Hydraulic flow data acquired at the site is a good indication that a fire pump will not be required. However, calculations will be performed to confirm.

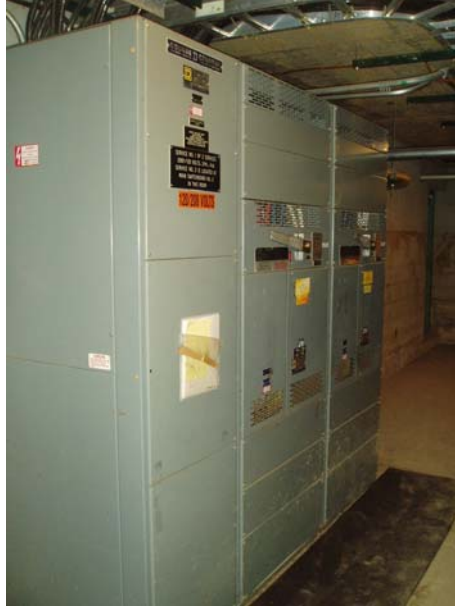
Figure E-1. Service Entrance Equipment One

- The facility currently has two electrical services provided by West Penn Power.
- Service entrance equipment one is located in a dedicated room adjacent to the boiler room. The equipment is rated 2500 amps, 208/120 volt, three phase, four wire (see Figure E-1). This service is fed underground from utility pad-mounted transformers. This equipment backfeeds the original service entrance equipment located in an adjacent room (see Figure E-2). It is unknown as to when this service was upgraded.

- All of the panelboards, motor starters, and disconnect switches are in fair to poor condition and are located in corridors, closets, and mechanical rooms.
- Recommendation:
 - Review service size with future building renovation and power capacity needs. Consolidation of services is recommended capable of handling building load plus 25% spare capacity.
 - Replace switchboards and distribution equipment.

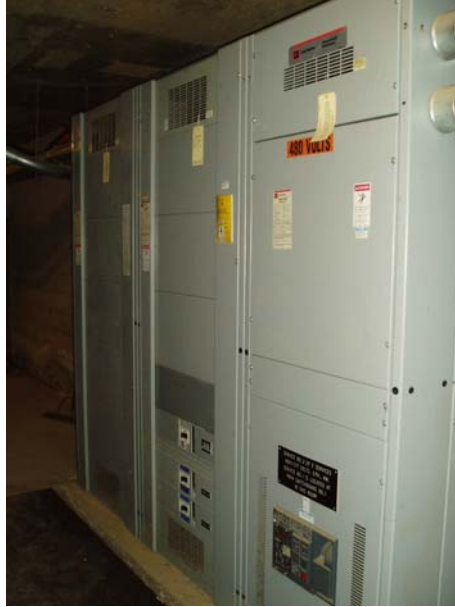
Figure E-3. Service Entrance Equipment Two

- Service entrance equipment two is located in the same room service entrance equipment one. The equipment is rated 1600 amps, 480/277 volt, three phase, four wire (see Figure E-3). This service is fed underground from utility pad-mounted transformer.

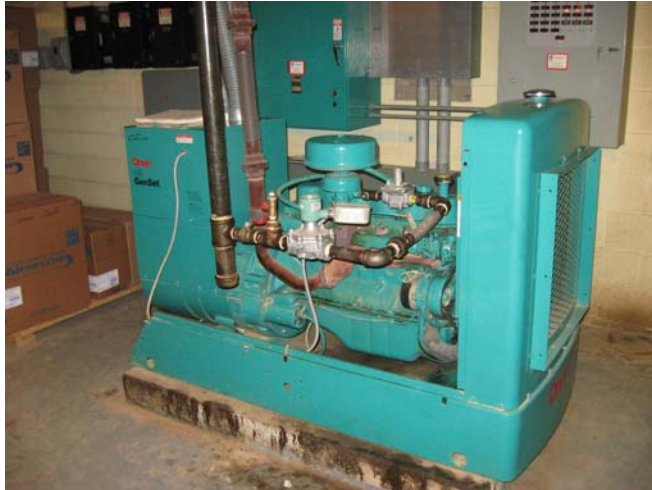
Figure E-4. Indoor Emergency Generator

- The building is served by two emergency generators. One is located in a room adjacent to the boiler room and the other one is located outdoors.
- Both generators are natural gas-fired.
- The generator located in the room adjacent to the boiler room is rated 45 kW, 208/120 volts, three phase, four wire and was installed in 1989 (see Figure E-4). The manufacturer is Onan. The 45 kW generator feeds through a 200 amp rated automatic transfer switch which feeds an 225 amp emergency panelboard.

- The majority of the connected load associated with the indoor generator is life safety systems (i.e. emergency lighting, fire alarm, paging system, etc.). Selected HVAC and plumbing equipment is also connected to the emergency distribution system.
- The generators are tested once per week per NFPA standards.
- The generators are serviced by an outside service company.
- Recommendation:
 - The indoor generator, transfer switch, and emergency distribution equipment should be replaced. A comprehensive review of what systems are desired to

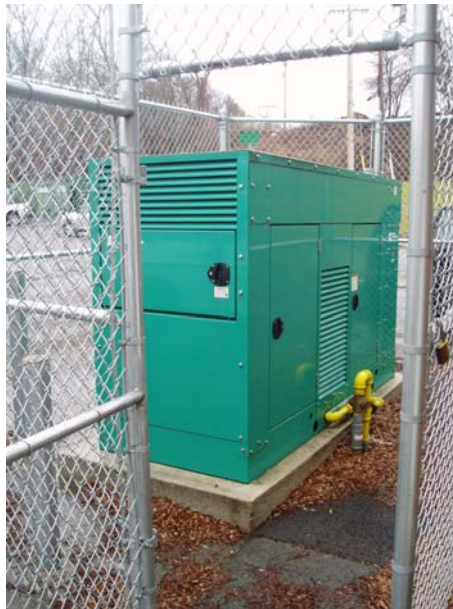
Figure E-5. Outdoor Emergency Generator

- The outdoor generator is rated 100 kW, 208/120 volts, three phase, four wire and was installed approximately 3-5 years ago. The manufacturer is Cummins (see Figure E-5). The 100 kW generator feeds through an automatic transfer switch which feeds emergency panelboards dedicated to the School Districts data center.

- The outdoor generator shall be remain.

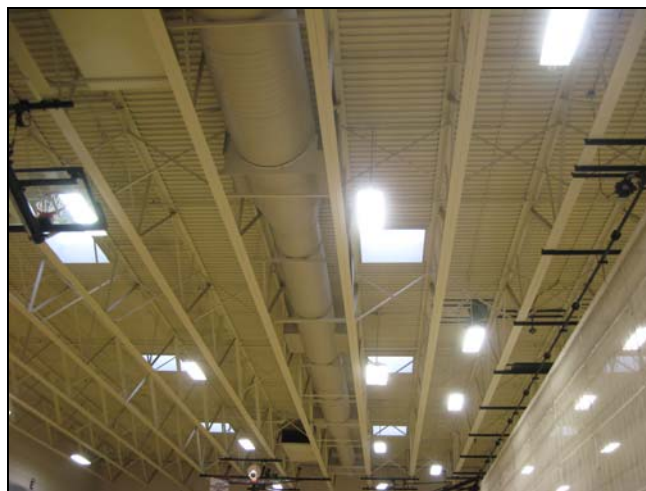
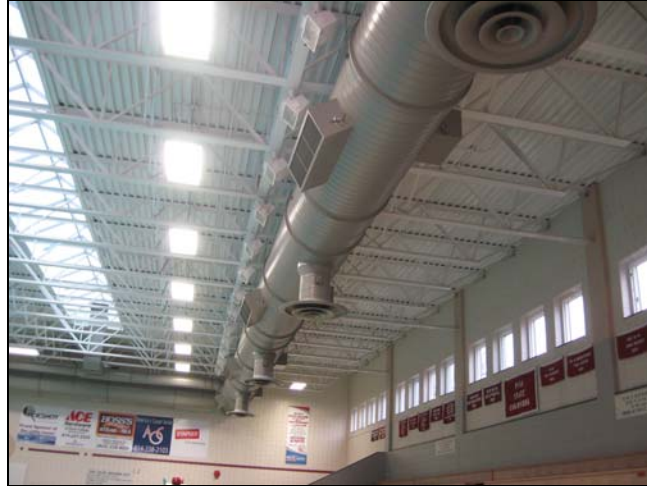
- The majority of the lighting in the building is T12. There are some T8 fixtures in the building, with T5 fixtures in the gymnasium and natatorium.
- Lighting control is switched.
- Gymnasium lighting is controlled by occupancy sensors.
- Exterior lighting is controlled by both switch and timeclock.

Lighting in Gymnasium

Lighting in Natatorium

- Recommendation:
 - Keep lighting and controls in the gymnasium and natatorium. Replace all T12 and T8 fixtures with more energy efficient lighting.
 - Occupancy sensors and lighting control should be installed to meet the requirements of the current Code.
 - Consider replacing outdoor lighting with LED type.
