State College Area School District
High School South Building
EXISTING CONDITIONS ASSESSMENT

Prepared by CenterPoint Engineering
08 February 2013

FACILITY ASSESSMENT SUMMARY

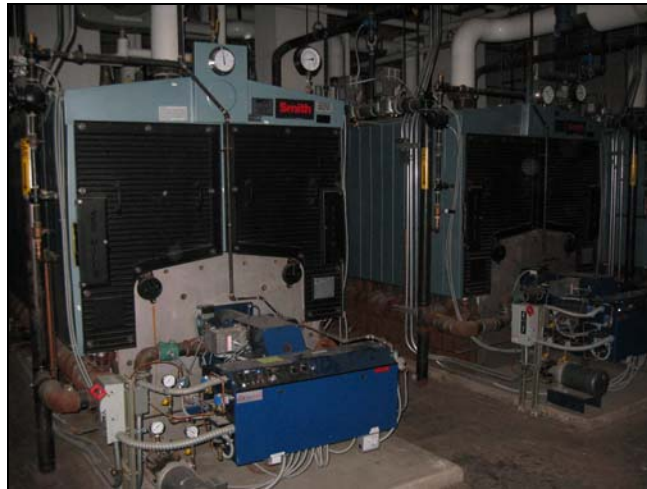
- The majority of the building is heating only.
- Heat is distributed throughout the building with hot water. The hot water is generated by three HB Smith 450 Mills cast iron sectional boilers. The boilers are gas-fired. They are approximately 8 or 9 years old and were reported to have no major issues.

Two of the Three Heating Water Cast Iron Sectional Boilers

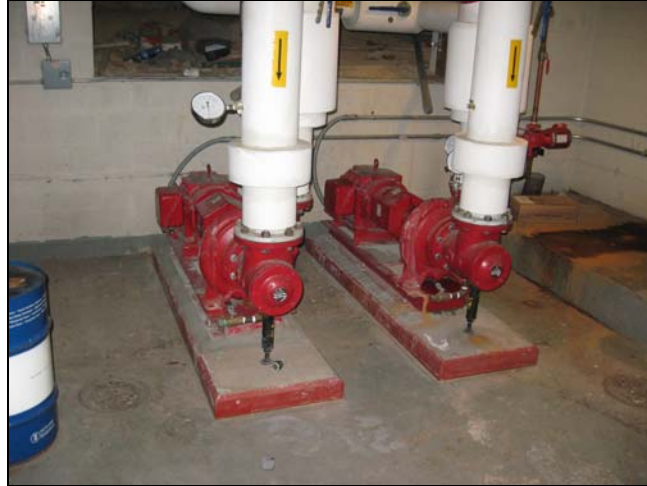
- Hot water is distributed by two base-mounted pumps which operate in a lead/standby arrangement. They were replaced at the same time as the boilers and are in good condition.

Heating Hot Water Circulation Pumps

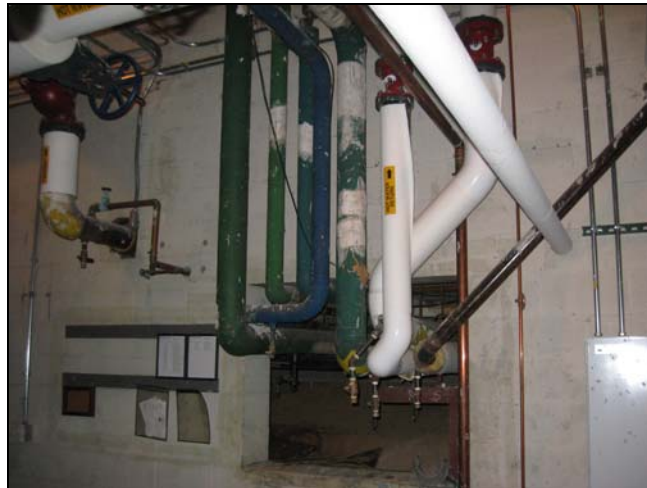
- Hot water is distributed throughout the building in copper and galvanized steel piping. Piping was reported to be in fair condition with sporadic leaks. The piping is insulated and is located in both the crawlspace and above ceilings. The lobby area has piping in the floor for a radiant slab heating system.

Piping Entrance into Crawlspace

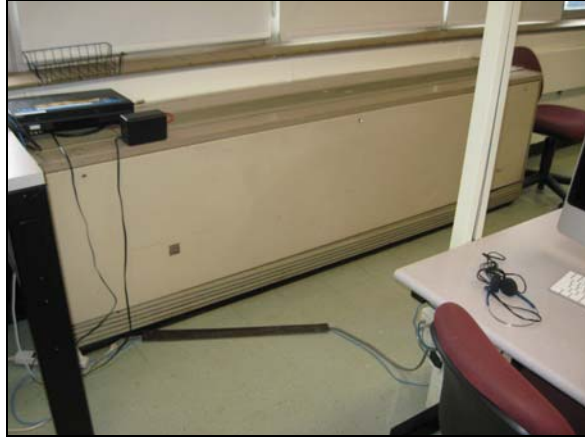
- Expansion tanks are less than 5 years old and in good condition.
- Classrooms in the building are heated by unit ventilators. Other large spaces are heated by indoor air handling units or rooftop air handling units. Smaller spaces are heated by fin-tube radiation and convector type units. The units serving the older areas of the building are in poor condition. Maintenance staff indicated many issues with the units including leaks and breakdowns.

Typical Classroom Unit Ventilator

- With the exception of the central plant equipment, the system should be replaced in its entirety with a more efficient system that provides adequate outdoor ventilation air.

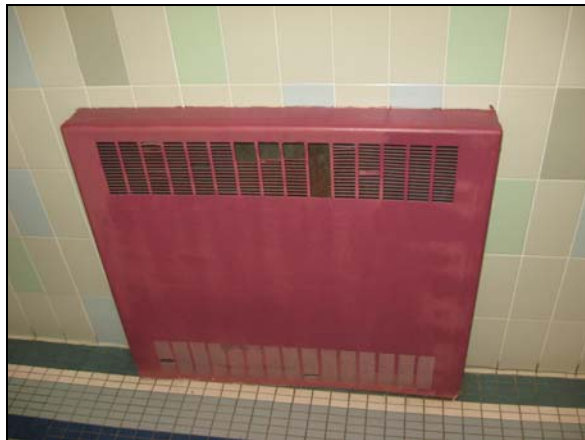
Typical Convector Type Unit

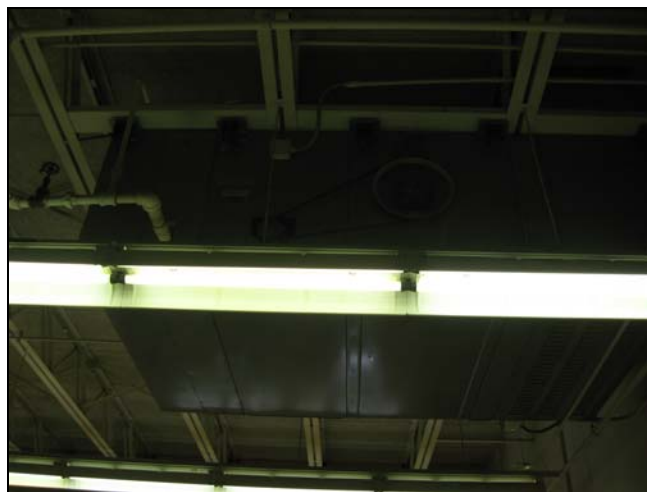
Indoor Air Handling Unit Horizontal Configuration Suspended by Structure Above

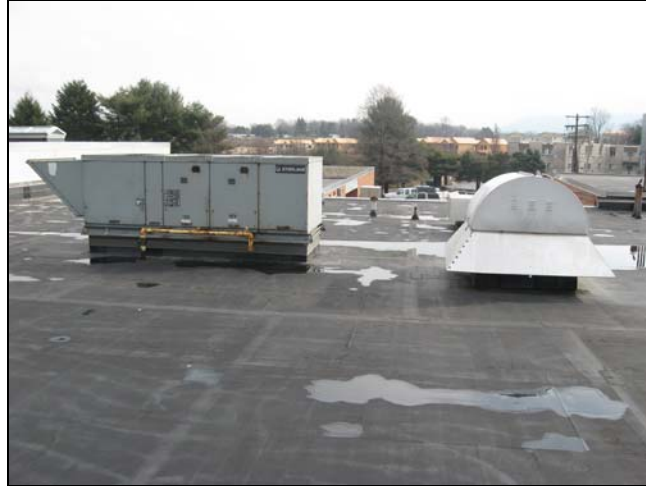
Kitchen Makeup Air Unit and Kitchen Hood Exhaust Fan

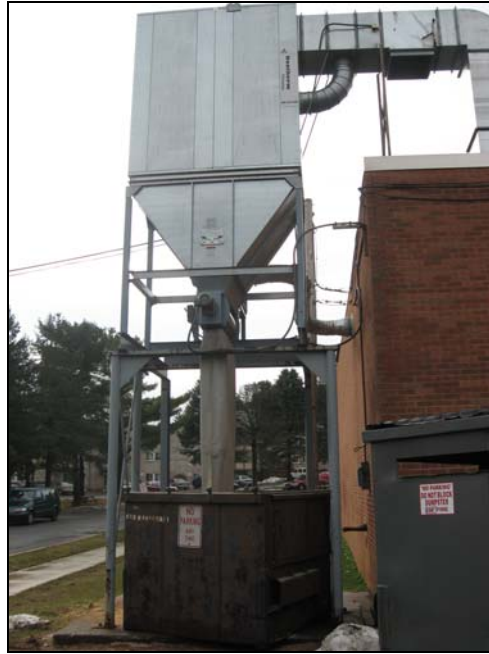
- The unit ventilators appeared to relieve air into the corridors. This is a violation of the current Code.
- The woodshop is served by a Dantherm dust collection system. The system is approximately 5 years old and appeared to be in good condition.

Dust Collection Unit for Woodshop

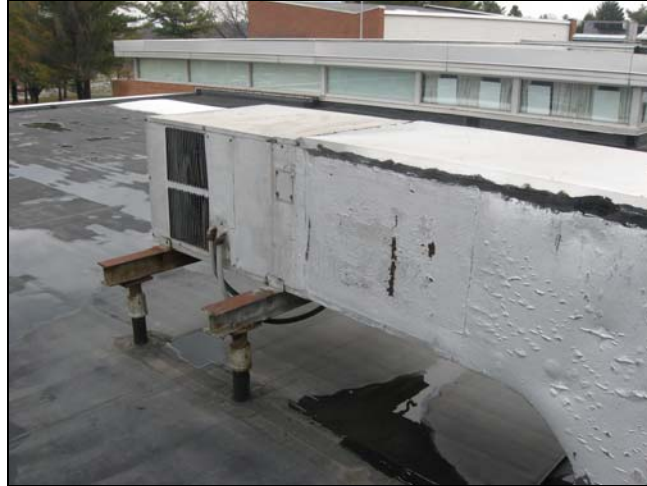
- The cafeteria, administration area, and nurse's area are air conditioned with packaged rooftop units that are original to the time of construction.

Packaged Rooftop Unit

- Recommendation:
 - With the exception of the shop rooftop unit and the library, the air conditioning equipment is at or near the end of its average service life and should be replaced.
 - Consideration should be given to providing air conditioning for the entire building.
 - Window units should be replaced with more efficient systems if these areas will continue to be air conditioned.

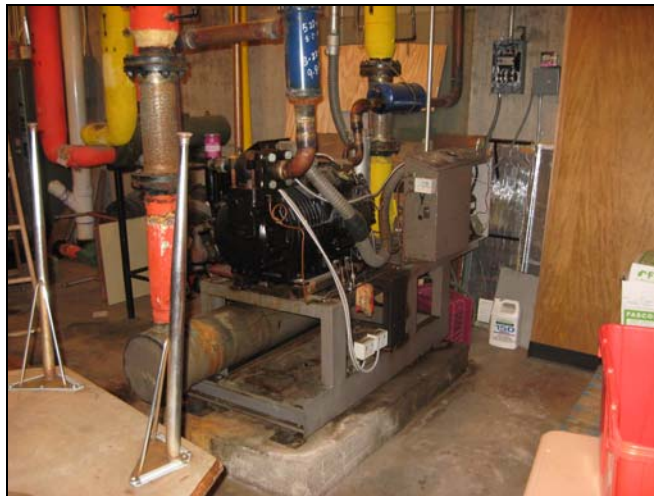
- The interior classrooms on the upper level are air conditioned with unit ventilators. These units are two-pipe, which means they use the same two pipes for both heating and cooling. There are 4 valves to isolate the chiller during heating season. The chiller is a split tube with an air-cooled condenser section and an indoor coil bundle section. The chiller appeared to be original. However, the compressor on the indoor section appeared to be relatively new.

Indoor Section of Chiller

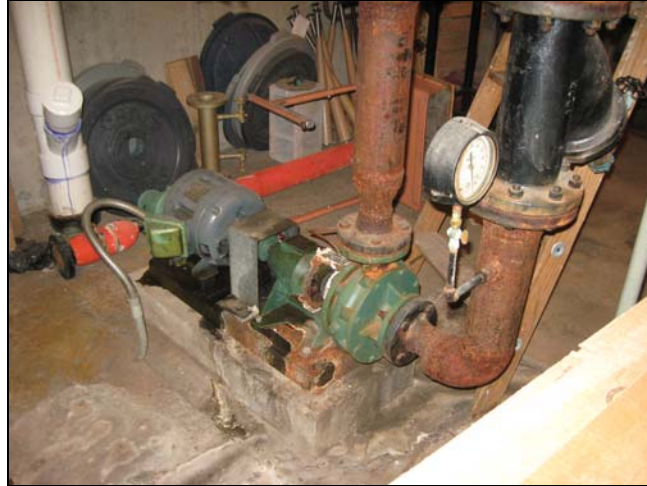
Chilled Water Pump

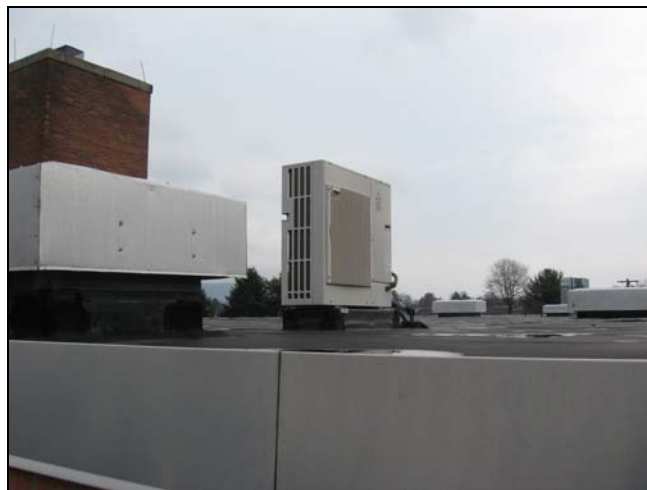
- Guidance, special needs areas, and classrooms are served with window air conditioning units.
- The library is served by a packaged rooftop unit that was added approximately 5 years ago. The unit was reported to be in good condition.
- The Cat kitchen is also served by a packaged rooftop unit that is approximately 15 years old. No major issues were reported with this system.
- There are two shops served by rooftop units. One was reported as approximately 5 years old, the other is approximately 12 years old. No major issues were reported with these systems.
- Data rooms are conditioned with ductless split systems. Age was unknown. However, they appeared to be in fair to good condition.

Outdoor Section of Ductless Split System

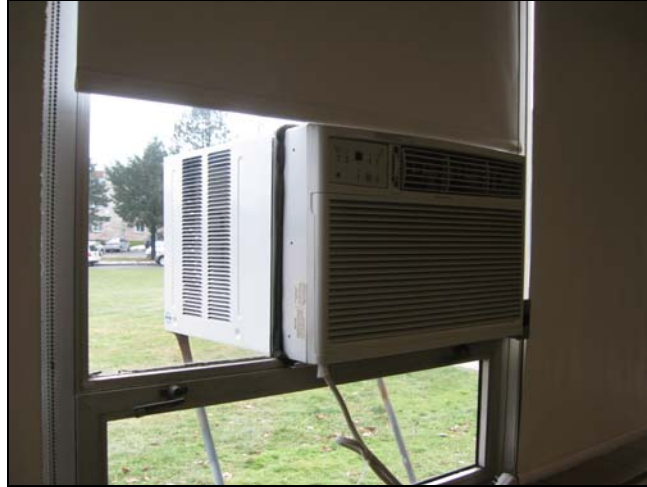
Window Air Conditioning Unit

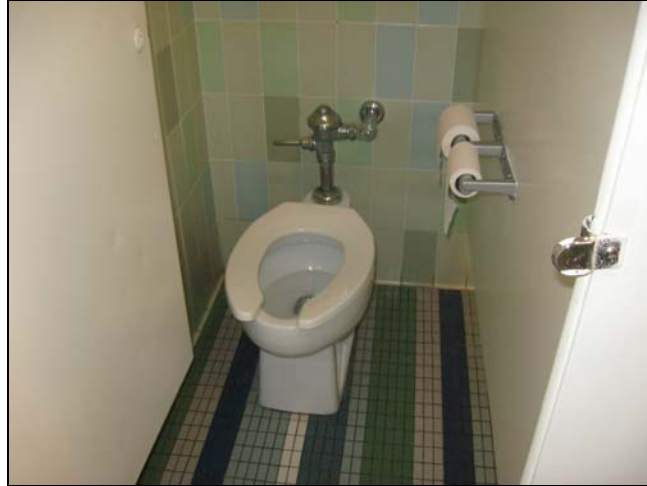
- Water closets are floor-mounted flush valve type.

Water Closet

- Plumbing fixtures are original to their time of construction. Maintenance indicated that the faucets are falling apart.
- It is assumed from the time of construction, that the fixtures do not meet current water flow requirements.
- Recommendation:
 - Plumbing fixtures should be replaced.

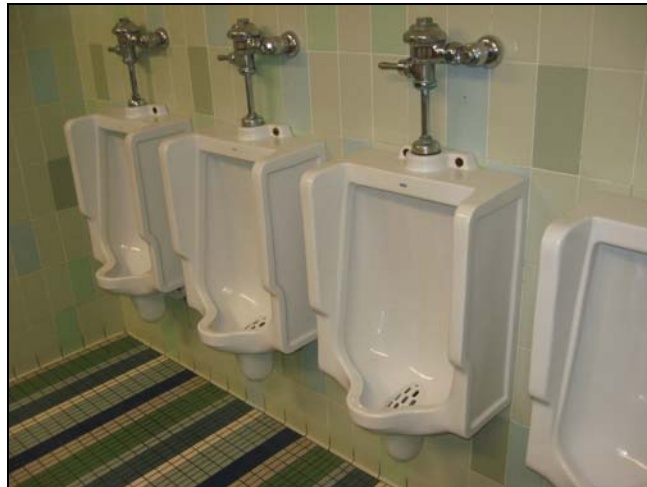
- Urinals are wall-mounted flush valve type.

Urinal

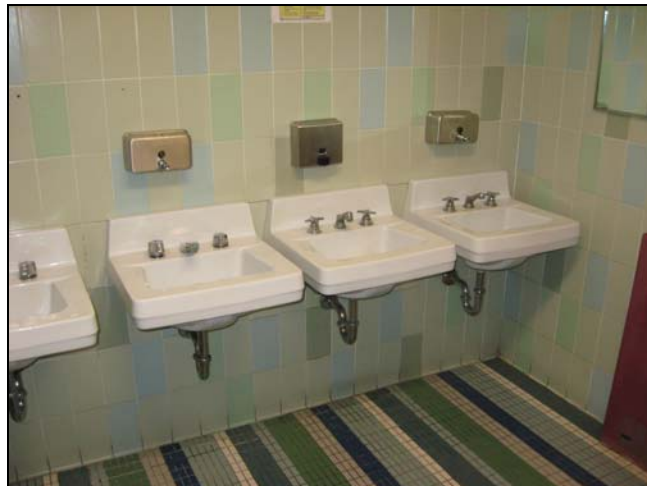
- Lavatories are wall-mounted type with a variety of faucet/handle styles.

Lavatories

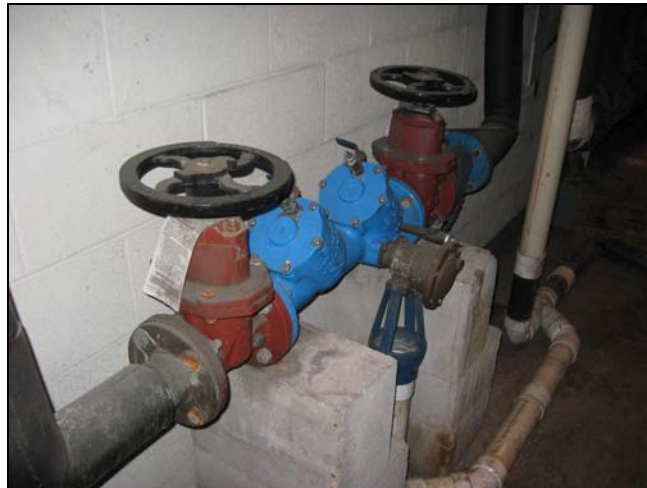
- Water service is provided by the State College Borough Water Authority.
- The water service enters the building in the boiler room. There is a Zurn Wilkins 3" backflow preventer to protect the service. A three meter assembly is also located within the boiler room as well as a pressure reducing valve.

Backflow Preventer at Water Service Entrance

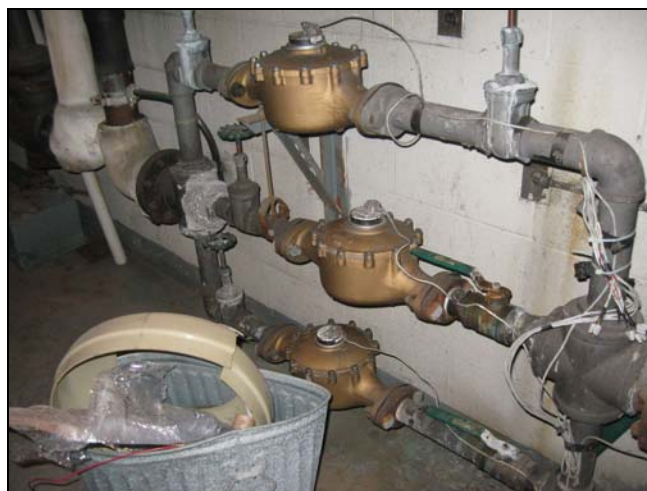
Domestic Water Meter Assembly at Water Service Entrance

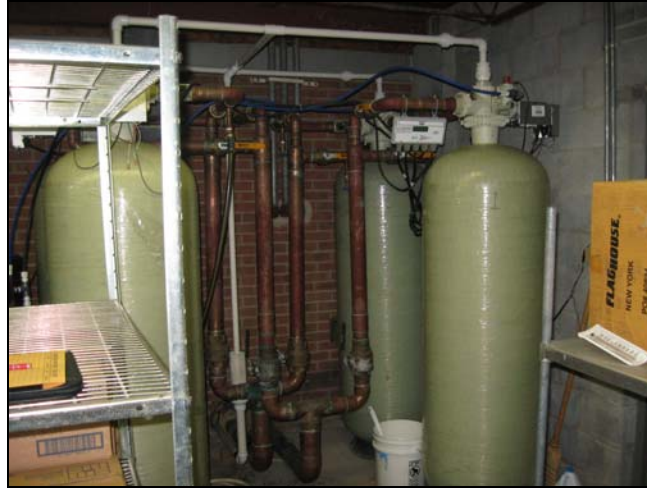
- An Ecowater water softener is located in an adjacent space. It was installed 4 to 5 years ago. Maintenance staff reported that this serves the entire building. It is in good condition.

Water Softening System

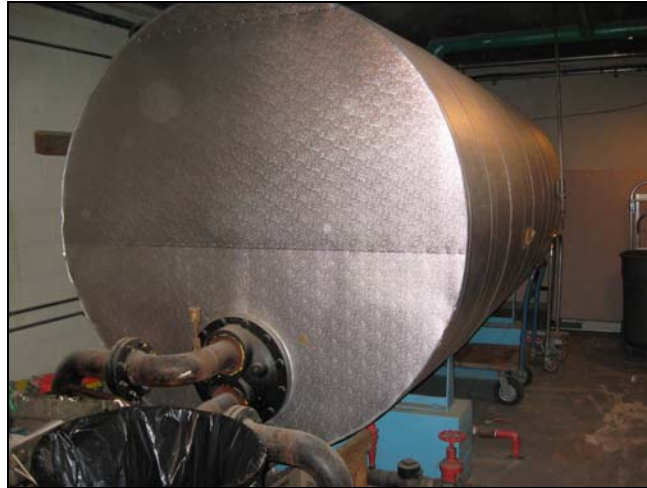
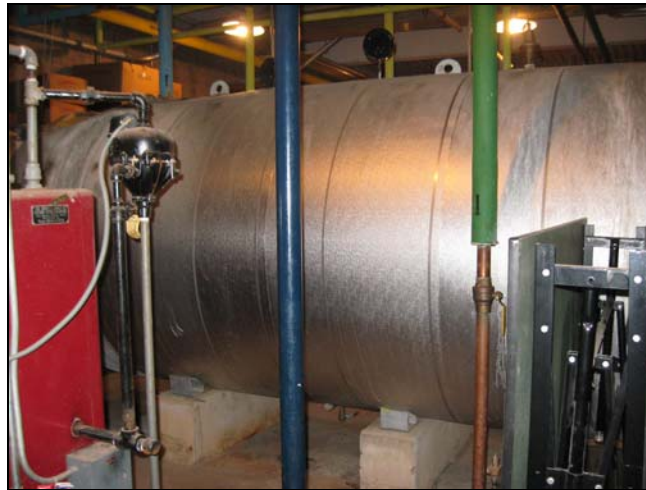
- Domestic hot water is generated by two boilers each with a separate storage tank. One system serves the upper level, and the other serves the lower level. These units are original to their time of construction. Maintenance staff indicated no major issues.

Domestic Hot Water Storage Tank

- Recommendation:
 - The domestic hot water generating systems should be replaced because the equipment is beyond its average service life. A more efficient system type should be reviewed including strategic placement of domestic hot water generating systems if possible.

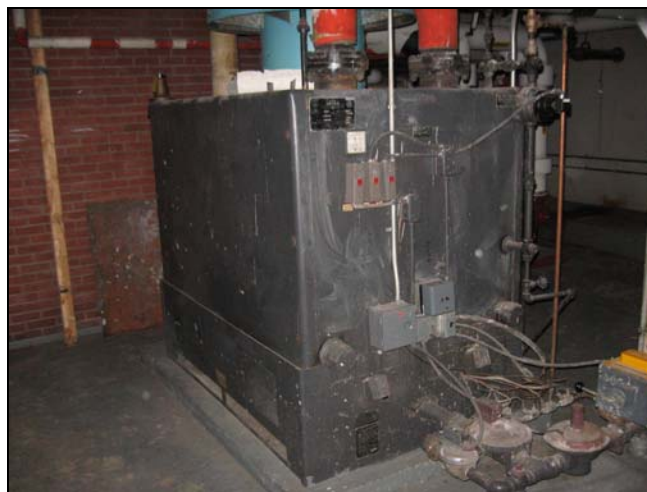
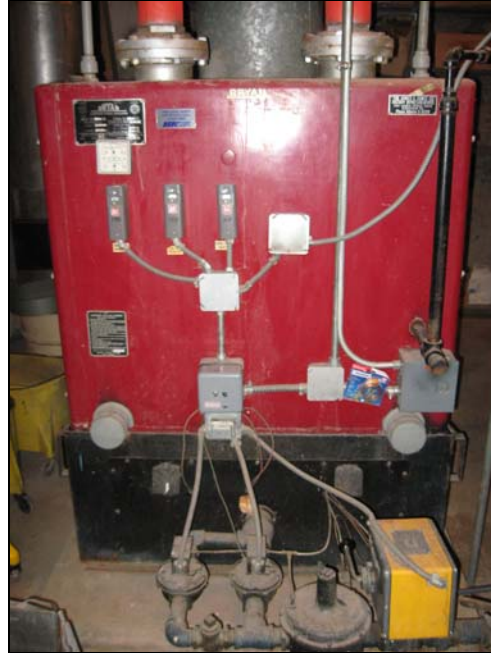
Boiler Used for Domestic Hot Water Generation

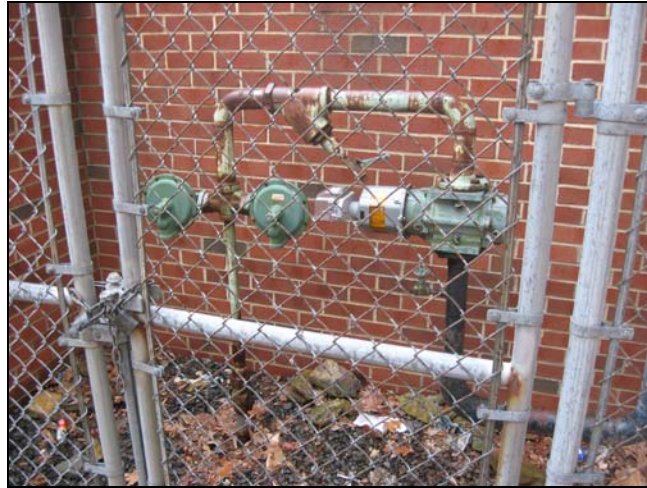
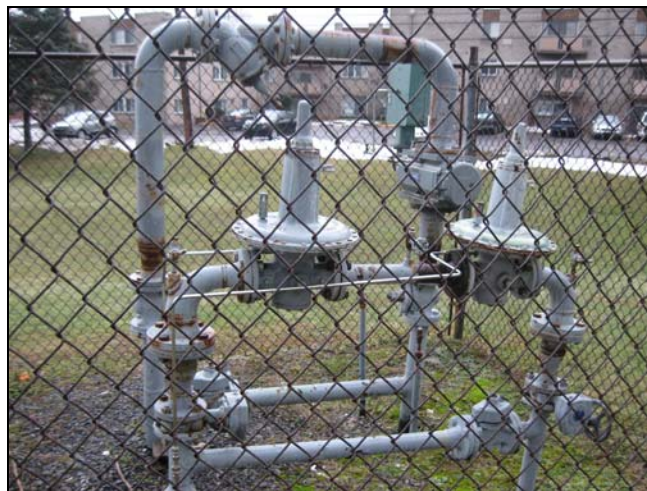
Natural Gas Service Entrance

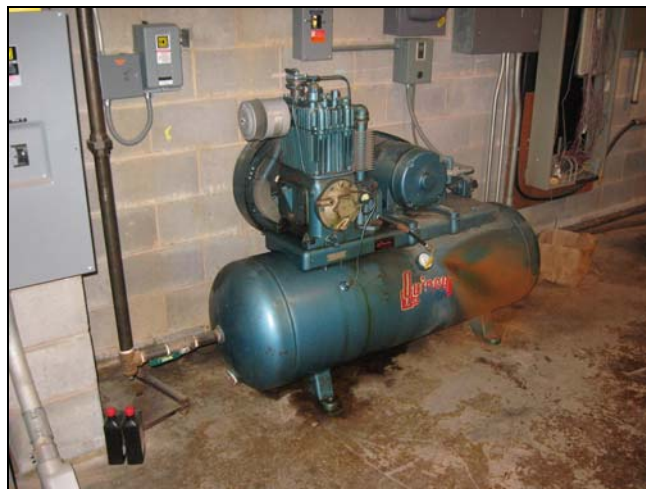
- An air compressor is located in the boiler room to serve the wood shop. The time of installation is unknown. The unit was reported to be in fair condition.

Air Compressor for Wood Shop

- Recommendation:
 - Replace the air compressor with more efficient unit.

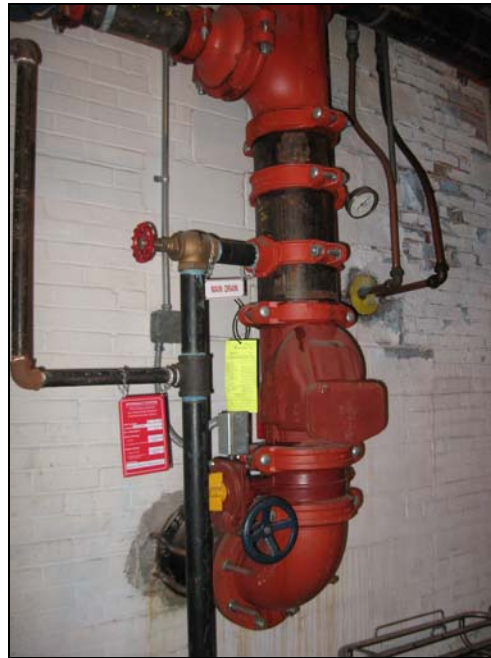
- The cafeteria area is served by an automatic sprinkler system. There is one riser located in the boiler room.
- Design data was listed on the valve as 413 GPM at 61.6 psi.

Sprinkler Water Service Entrance

- The pressures listed on the testing tag were 130 psi static pressure and 68 psi residual pressure. No flow data was logged.
- The building does not have a fire pump.
- Recommendation:
 - Extend the system to cover the entire building. This may require a new water service. Hydraulic flow data acquired at the site is a good indication that a fire pump will not be required.

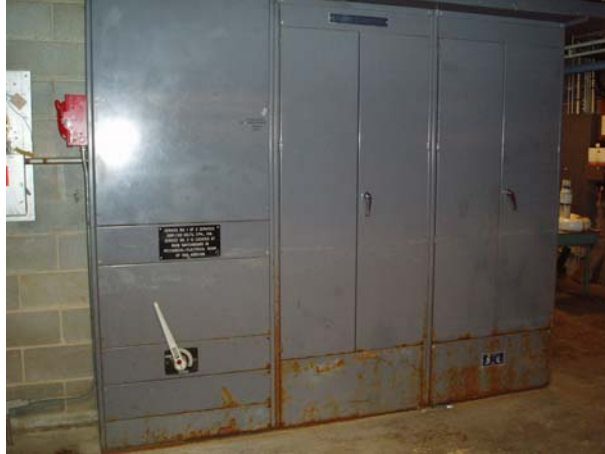
Figure E-1. Service Entrance Equipment One

- The facility currently has two electrical services provided by West Penn Power.
- Service entrance equipment one is located in the boiler room of the lower level and is original to the facility. The equipment is rated 1600 amps, 208/120 volt, three phase, four wire (see Figure E-1). This service is fed underground from utility pole-mounted transformers. It is unknown if the utility service and/or utility service equipment was ever upgraded.

- All of the panelboards, motor starters, and disconnect switches are in fair to poor condition and are located in corridors, closets, and mechanical rooms.
- Maintenance staff indicated capacity issues.
- Recommendation:
 - Review service size with future building renovation and power capacity needs. Consolidation of services is recommended capable of handling building load plus 25% spare capacity.

- Replace switchboards and distribution equipment.

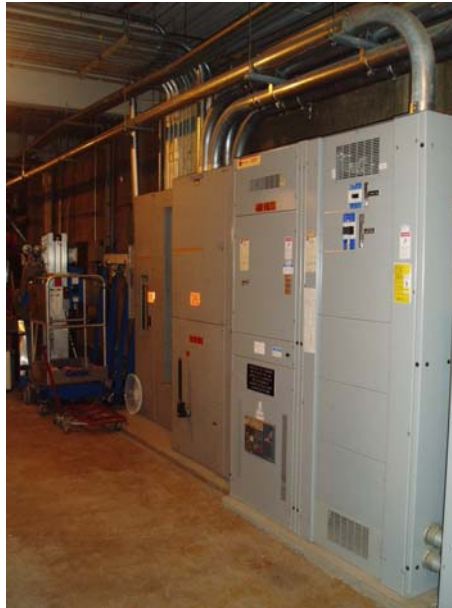
Figure E-2. Service Entrance Equipment Two

- Service entrance equipment two is located in the mechanical room of the upper level. The equipment is combination of units installed in 1965 and 1999. The equipment installed in 1965 is rated 1600 amps, 208/120 volt, three phase, four wire. The equipment installed in 1999 is rated 1600 amps, 480/277 volt, three phase, four wire. The 1999 equipment feeds the 1965 equipment via a 500 kVA indoor-pad mount dry-type transformer (see Figure E-2). This service is fed underground from utility pad-mounted transformer.

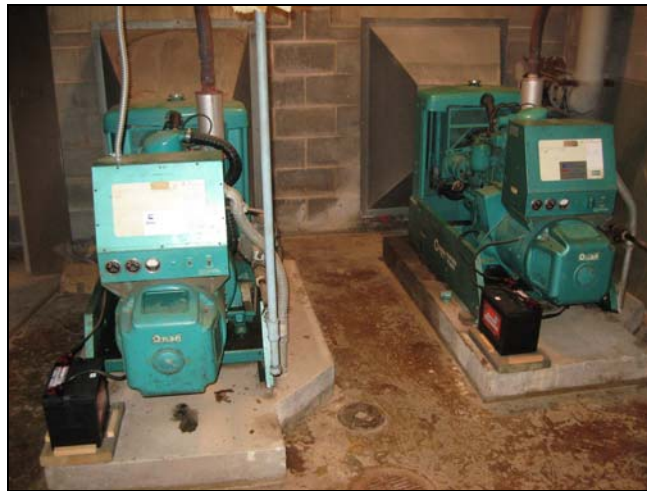
Figure E-3. Lower Level Generators

- The building is served by three emergency generators. Two are located in the boiler room and serve the lower level. The third is located in the mechanical room and serves the upper level.
- All three generators are natural gas-fired.
- The generators serving the lower level are rated 15 kVA, 120/240 volts and 18.75 kVA, 120/208 volts (see Figure E-3). The manufacturer is Onan. The 15 kVA generator feeds through an 100 amp rated automatic transfer switch which feeds an 100 amp fusible, split-bus emergency panelboard. The emergency system associated with the 18.75 kVA generator was not apparent during the survey.

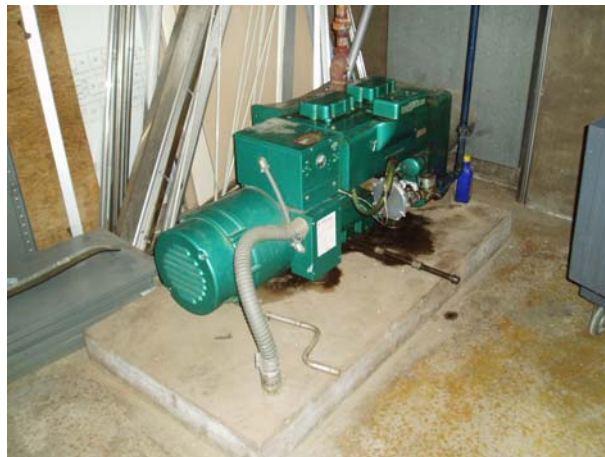
Figure E-4. Upper Level Generator

- The generator serving the upper level is rated 18.75 kVA, 120/208 volts (see Figure E-4). The manufacturer is Onan. The generator feeds through a 60 amp rated automatic transfer switch which feeds an 100 amp fusible, split-bus emergency panelboard. An area protection panel, which monitors area lighting in the building, is also part of the emergency system.

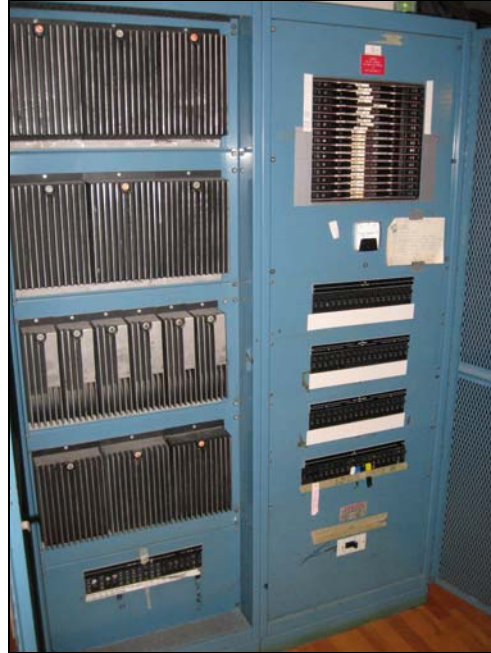
Stage Lighting Controls

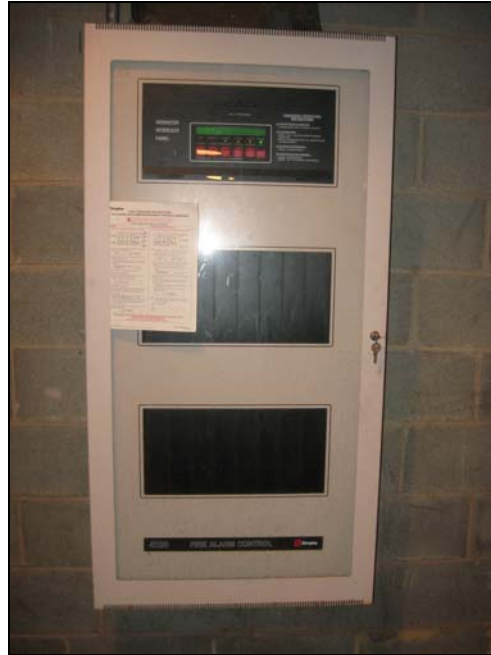
- One fire alarm system covers the entire building. The main panel is located in the boiler room. It is approximately 15 years old. The system is serviced once per year.
- There is no outside monitoring of the system.
- The 1999 wing has smoke detectors.

Fire Alarm Panel

- The lower level has bells, while the upper level and cafeteria have horns and strobes.
- Recommendation:
 - The system should be replaced and brought up to current Code requirements.
