State College Area School District
High School South Building
EXISTING CONDITIONS ASSESSMENT

Prepared by CenterPoint Engineering
08 February 2013

FACILITY ASSESSMENT SUMMARY

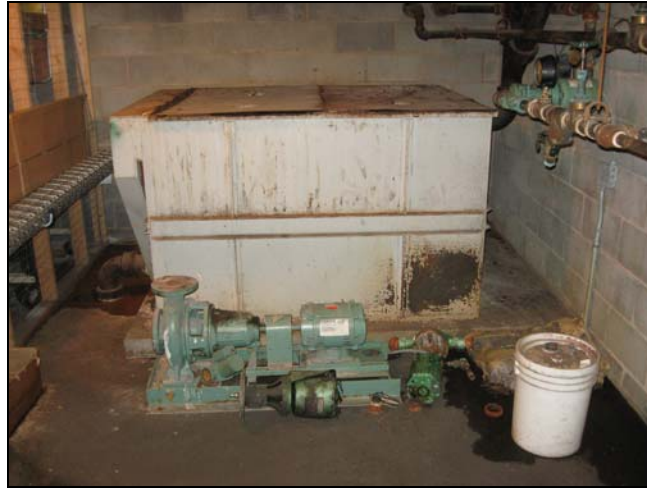
- Maintenance staff indicated that the system must be snaked approximately once a month.
- There are two grease interceptors that serve the building. The unit serving the upper level is located outside. It was believed to be approximately 10 years old. The lower level is located in the boiler room. It is original. Both units were reported to leak and clog. Maintenance staff indicated that they are pumped out once a year.

- Recommendation:
 - Piping should be scoped to determine condition of pipe interior. This will also determine areas of uneven slope and potential leaks.
